# Effects of Flooding on Recreational Access and Navigation on the Llano River and Lake LBJ

## Lyndon B. Johnson Reservoir Survey Results

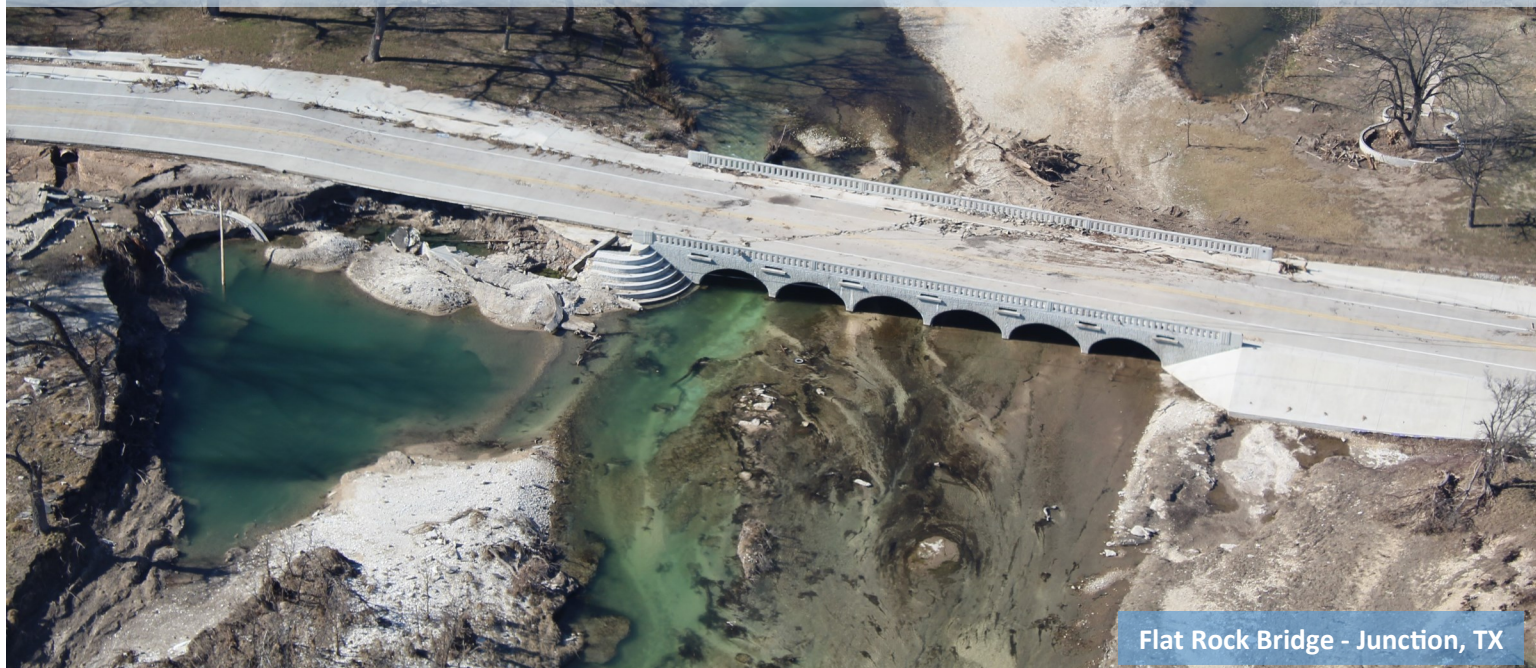
Flat Rock Bridge - Junction, TX

- Areas of significant streambank erosion were observed. Most existed before the 2018 flood but may have been exacerbated. Notable exceptions include the Flat Rock Bridge in Junction (pictured on front page) and areas where stabilizing vegetation had been removed prior to the flood. The South Llano River State Park incurred significant erosion and damage to TPT signage, park trails, primitive campgrounds, and the river tubing takeout.

- Allow river to assimilate sand and gravel material through natural fluvial processes and revegetation.
- Provide resources to local parks, RACA sites, and TPT sites to improve access, rebuild signage and kiosks, and stabilize river banks.
