Floods on the Llano River, Texas — Fall 2018-DRAFT

Llano River Watershed Alliance

Tyson Broad - January 4, 2019

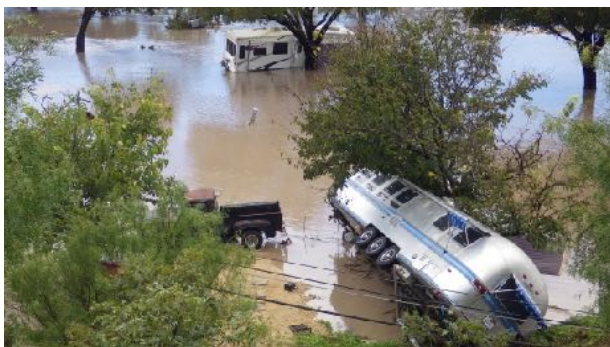
Figure 8. Destroyed RVs on South Llano River

South Llano River, were inundated by floodwaters. Fifteen campers were rescued by boat and four by helicopter. Tragically, the bodies of four campers were recovered downstream, one as far downstream as LBJ Reservoir.

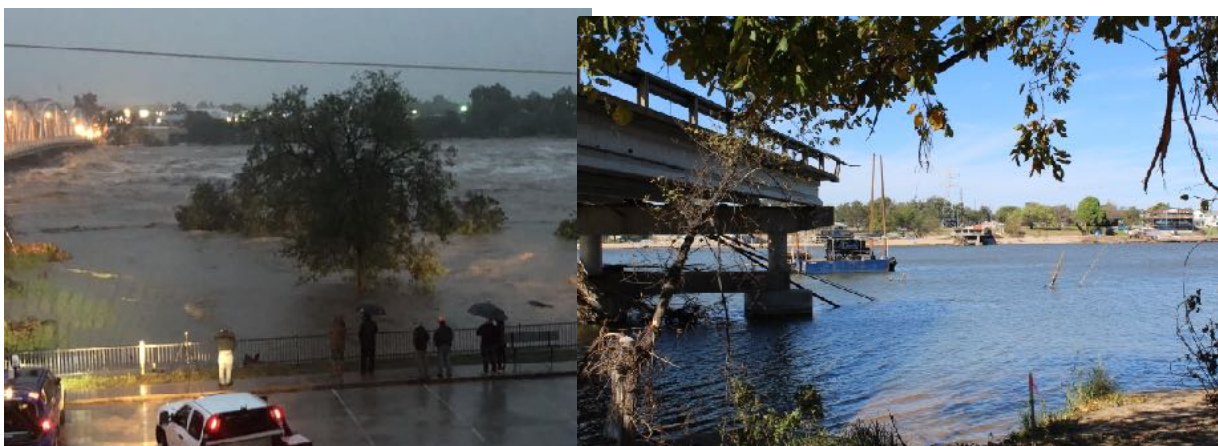
community of Kingsland. Floodwaters approached, but did not reach the bottom of the Hwy 16 bridge in the City of Llano; no damage was sustained by the bridge (Figure 13).

Figure 13. Left: Llano River at City of Llano, morning of October 16, 2018. Photo by Dana Wright. Right: Destroyed Hwy 2900 Bridge over Llano River Arm of LBJ Reservoir, November 3, 2018.

The Hwy 2900 bridge over the Llano River Arm of LBJ Reservoir was destroyed by the October 16 flood. This crossing did not provide recreational access.

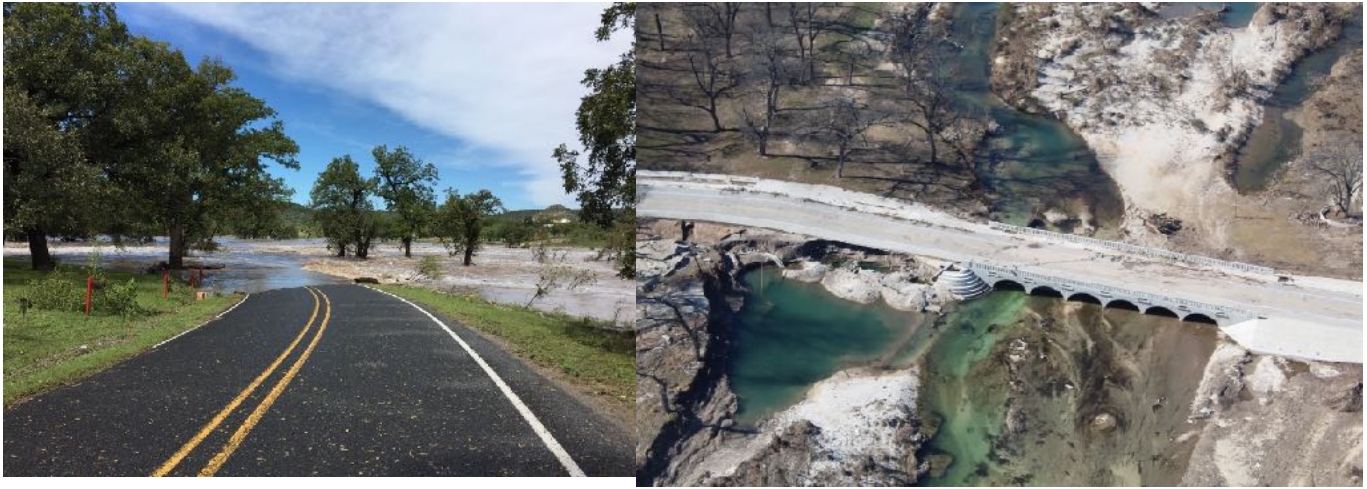
In the upper watershed, rainfall amounts in excess of nine inches resulted in a flooding of the South Llano River, which that reached almost 26 ft at 8:15 am on Tuesday morning, just 0.6 ft below the Columbus Day Flood. Flood waters again overtopped Flat Rock Crossing on the South Llano River near Junction resulting in significant damage to the bridge (Figure 14). As

Figure 14. Left: Southern approach to Flat Rock Bridge near Junction - October 9, 2018. Right: Aerial view of Flat Rock Bridge looking west - December 14, 2018

of December 2018, Flat Rock Crossing remains closed to vehicular traffic, and debris is blocking the river passage by paddlers. Flat Rock Crossing served as an access point for the on the South Llano River Paddling Trail, but access is currently closed until repairs can be made to the bridge and paddler access facilities.

The South Llano River Paddling Trail between South Llano River State Park and the City of Junction was severely affected. The most significant impact was the damage to the Flat Rock Crossing. A crack in the surface of the bridge forced closure of the bridge and debris continues to block the arched culverts beneath the bridge, thus making the paddling

The primary artificial hazards are the KC 310 Bridge downstream of Junction and the Flat Rock Crossing located just upstream of Junction. Although the KC 310 Bridge has been a hazard for some years, with flood mitigation efforts likely resulting in a temporary surge in capacity for recovery efforts in the Llano River, this is likely an ideal time to revisit and address the situation.

Removal of the debris will facilitate paddler passage at the bridge to continue downstream to the paddling trail takeout at Junction City Park, immediately below the South Llano River Bridge. However, due to the uncertainties regarding reconstruction of the Flat Rock Crossing and resulting access by vehicles and paddlers, there may be merit in establishing a temporary RACA site upstream of Flat Rock Crossing in order to reestablish use of the paddling trail. Kiosk and signage for the South Llano River Paddling Trail will also need to be replaced at all three paddling trail access points, located at the South Llano River State Park, Flat Rock Crossing, and Junction City Park.

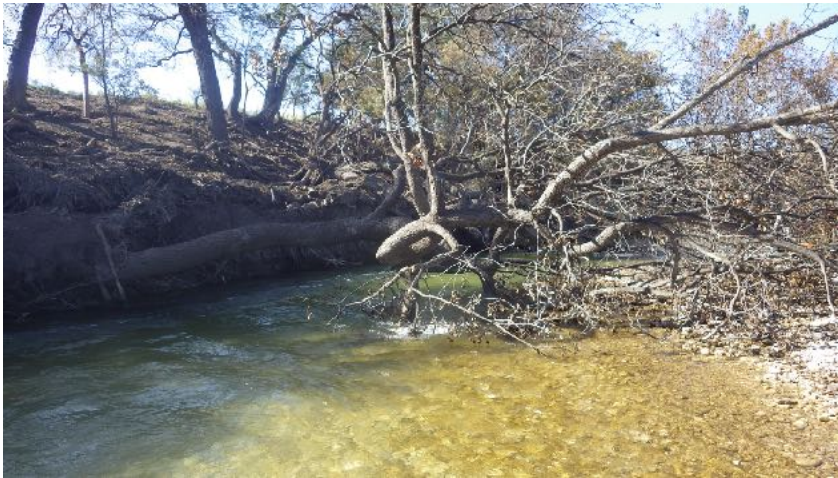
Within the channel itself, considerable scouring occurred, removing patches of aquatic vegetation. However, it is noted that certain snags remained anchored in the river, providing cover for aquatic species in the crystal clear waters of the river following from the flood. Additional large woody debris also fell into the river from eroding streambanks. While this can create a navigation hazard and decrease bank stability and potential shade along the river, it does provide additional habitat for fish and other aquatic species (Figure 17).

Figure 17. Large woody debris along South Llano River near South Llano River State Park, November 5, 2018

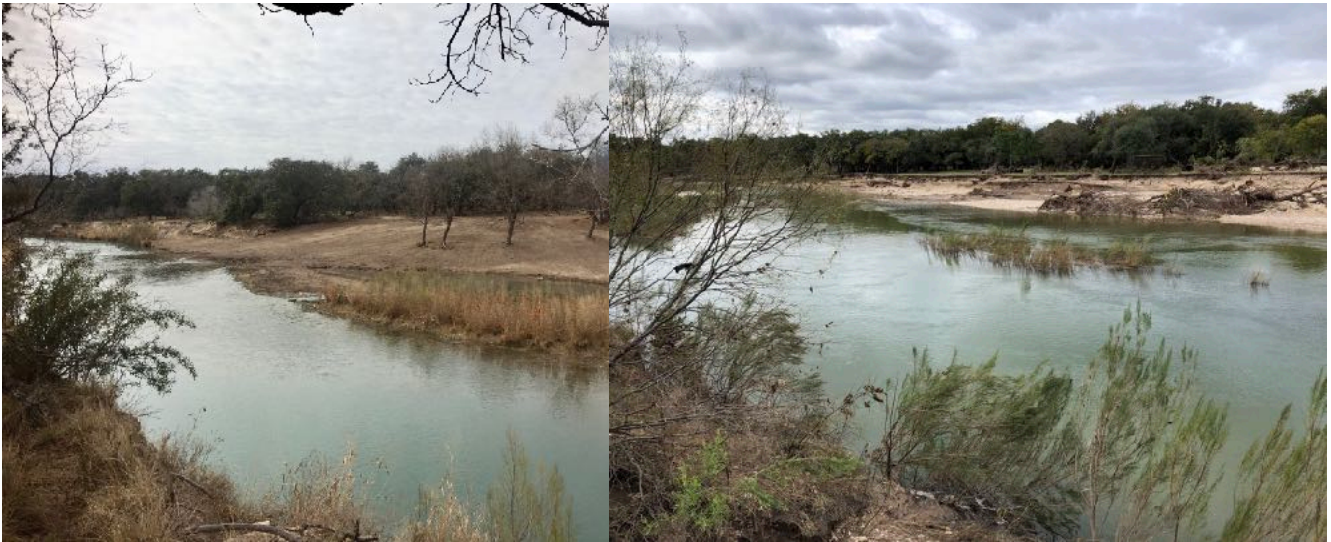
tailed deer and axis). Such additional protection will help offset the more than thirty wildlife exclosures in the riparian zones that were damaged or destroyed in the flood. In one location along the South Llano River, a riparian areas that was bulldozed by an uninformed landowner earlier in the year was destroyed and a cut bank left in its place (Figure 18).

Figure 18. Before and after showing flood results (right) following bulldozing of riparian area in January 2018.

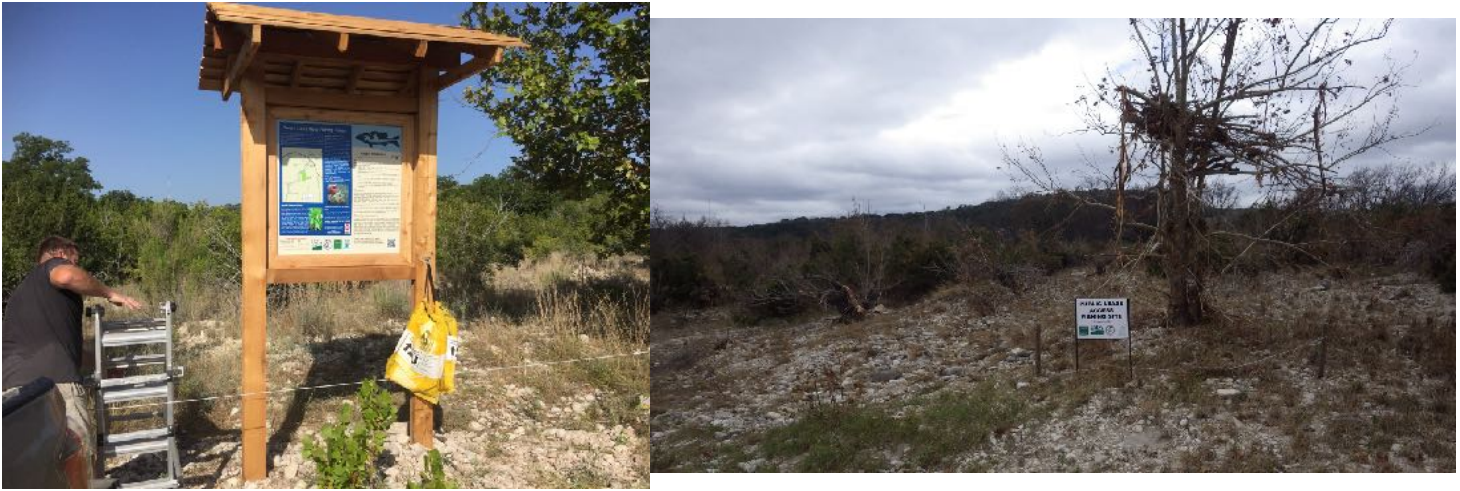
Figure 22. River Access and Conservation Area sign destroyed by October floods along South Llano River. Note: Kiosk was located to the left of tree.

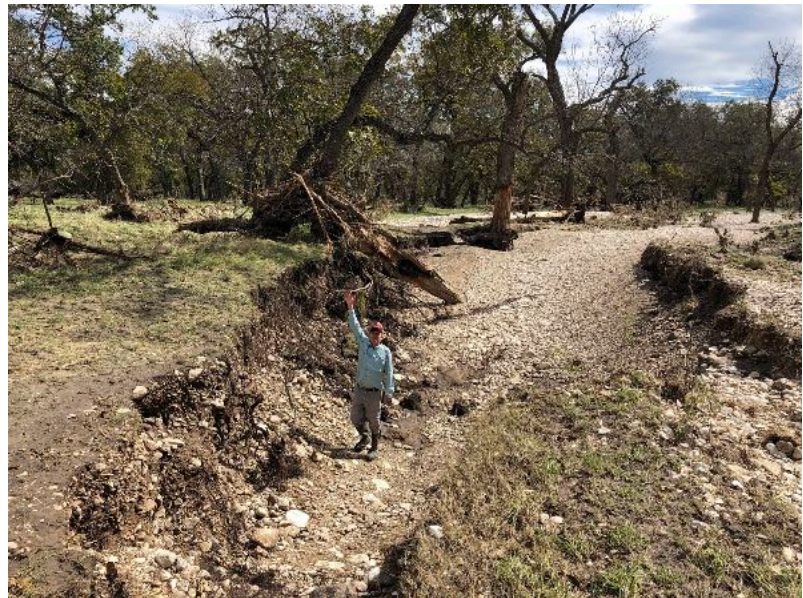
Figure 23. Scour hole along former Buck Lake Trail - South Llano River State Park. Photo: Megan Bean

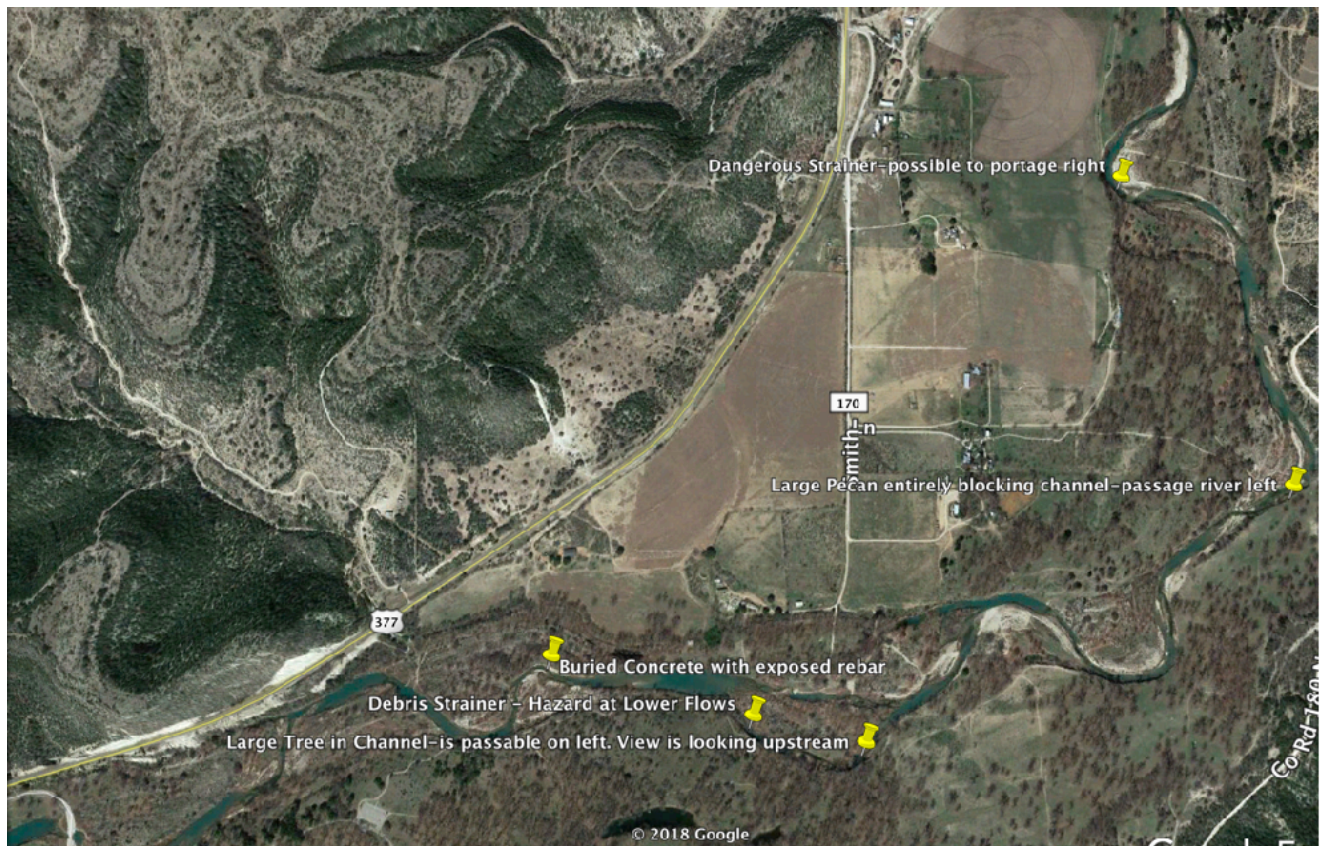
trail unusable at the previously established access points at the state park, Flat Rock Crossing, and the Junction City Park. The South Llano River Paddling Trail signs at Flatrock Crossing and the Junction City Park were washed away. Some of the additional navigation hazards along the South Llano River Paddling Trail, primarily downed trees, are shown in Figure 24. There is also a downed tree 0.4 miles above the Flat Rock Crossing.

Figure 24. Navigation hazards on South Llano River Paddling Trail following October flooding.

The Alliance also recommends the removal of both natural and artificial navigational hazards on the river. The primary natural hazards are downed trees that create hazardous ‘strainers’ where boaters could potentially be pinned against the woody debris by the current. Several of these ‘strainers’ have been identified on the South Llano River but passage can be restored by crews cutting passages through the downed trees with a chainsaw. Other natural hazards occur at the RACA sites along the river where some debris needs to be removed and parking areas, kiosks, and signage need to be reestablished.

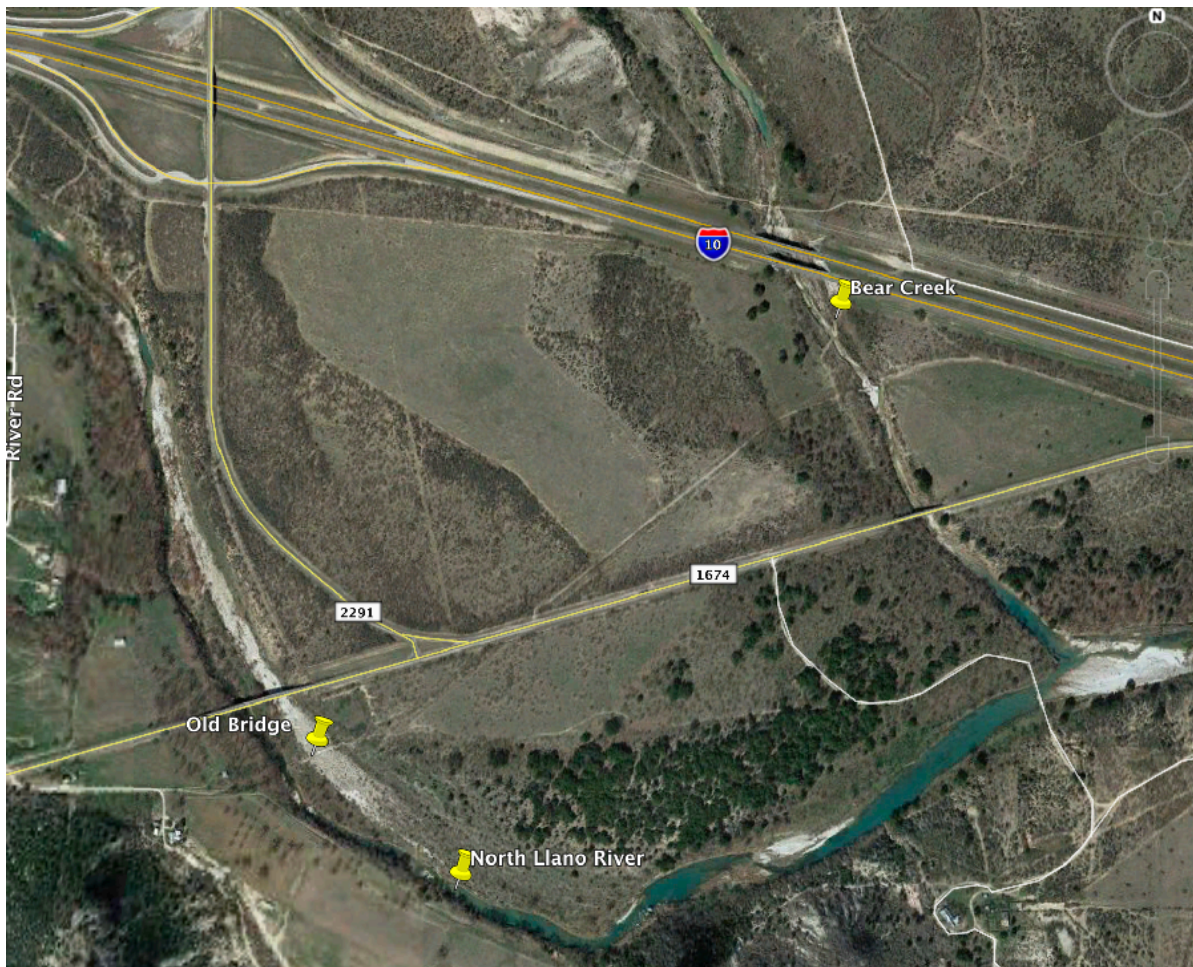
As noted in Figure 4, floodwaters on the North Llano River only reached a recurrence interval of about 1 in 5. Consequently, river access points at the crossings were not significantly impacted. It is not known what new navigation hazards were created along the entire river following the flood, but no hazards were noted along the lower stretch downstream of below Kimble County Road 271. An existing navigation hazard is located at an old bridge crossing of the North Llano above the confluence with Bear Creek (Figure 25).

Figure 25. Navigation hazard resulting from old bridge crossing of North Llano River above its confluence with Bear Creek.

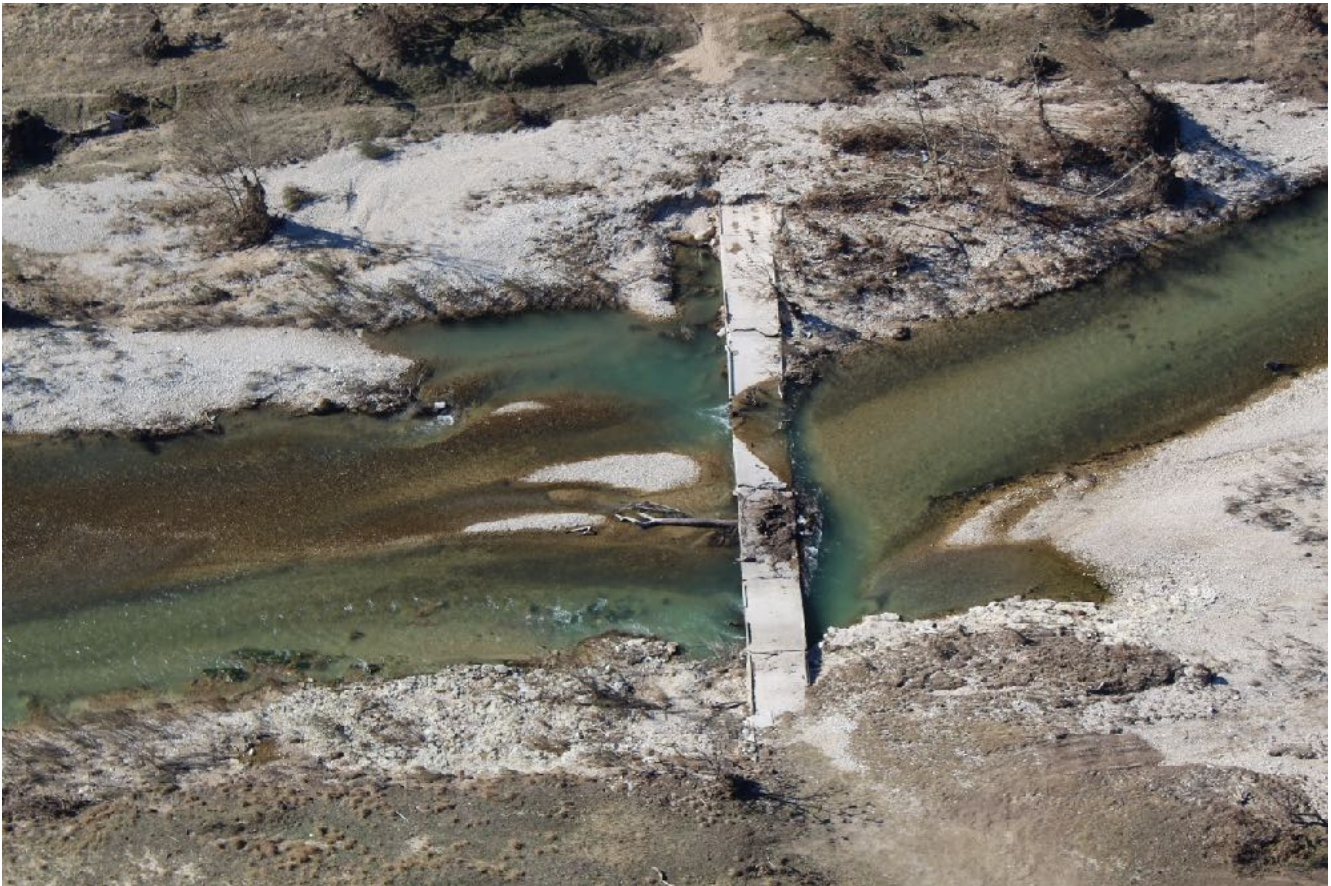
The largest navigation hazard along the mainstem of the Llano River downstream of Junction is the Kimble County Road 310 Bridge which was destroyed by floodwaters in the 1980s. As sections of the bridge have collapsed, paddlers must line their boats under the bridge in swift water. The potential for an accident is high (Figure 26).

Figure 26. Collapsed Bridge at Kimble County Road 310. Boaters must line unlined boats along swift current on river left (bottom)

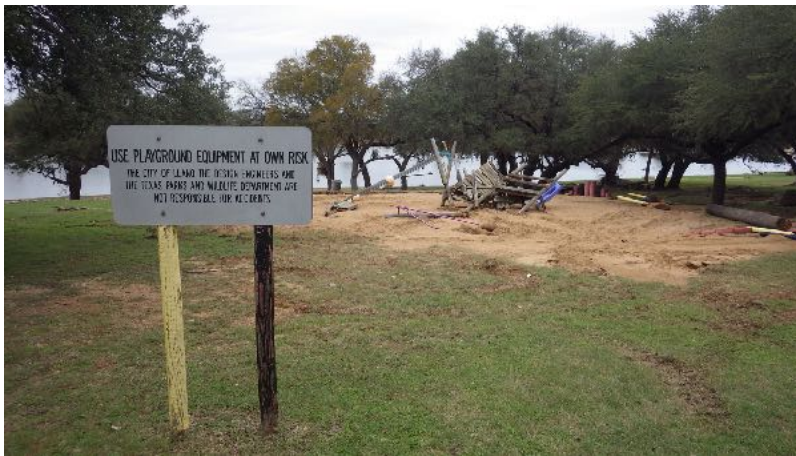
Figure 29. Damaged playground equipment, Robinson Park, Llano, Texas.

Robinson Park, Badu Park, and Crenwelge Park in the City of Llano are all located next to the Llano River, providing popular access points and recreational opportunities. All of the parks, suffered considerable damage to infrastructure (Figure 29), but have reopened for recreational access. The rock art displays in Crenwelge Park, site of the Llano Earth Art Festival, were destroyed.
