Watershed Week in Review

Llano River Watershed Alliance

Llano River contribution to Highland Lakes during drought

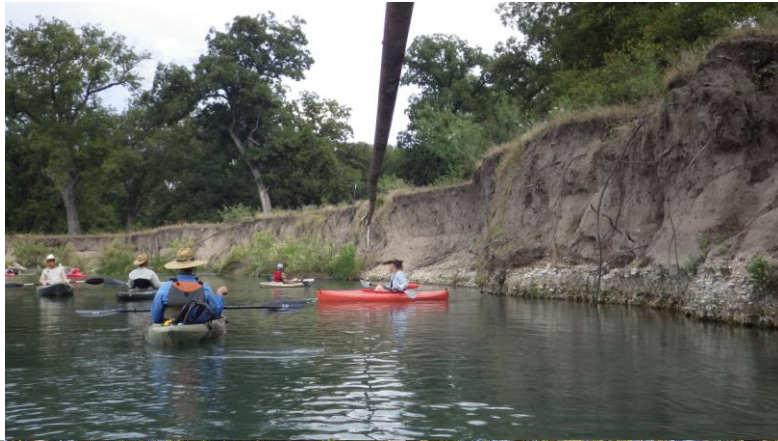
Last week's Watershed Week in Review showed areas along the South Llano River where more than 450 feet of stream bank erosion has occurred since 1974, exposing an old irrigation pipe (see left).

As mentioned, there are several reasons for this occurrence. One is runoff to the river from drought-plagued uplands; another is the lack of a good flood to help flush out the accumulating sediment in the channel. (It doesn't look like this current event is going to help much either.)

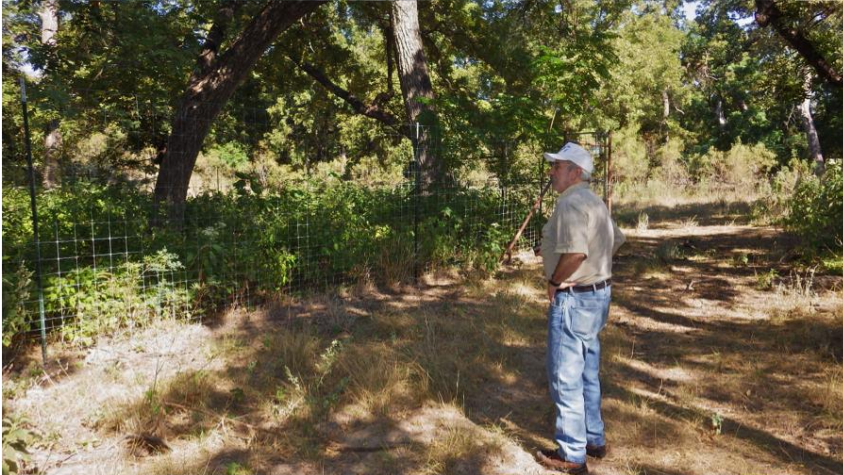
Another factor that is exacerbating this problem and causing increased runoff to the river is the high density of deer and axis in the riparian areas. Deer populations in this area should be about one deer per 10-12 acres. Yet some areas along the river currently have deer populations at one deer per $\frac{3}{4}$ acres. See the impacts (above and below).

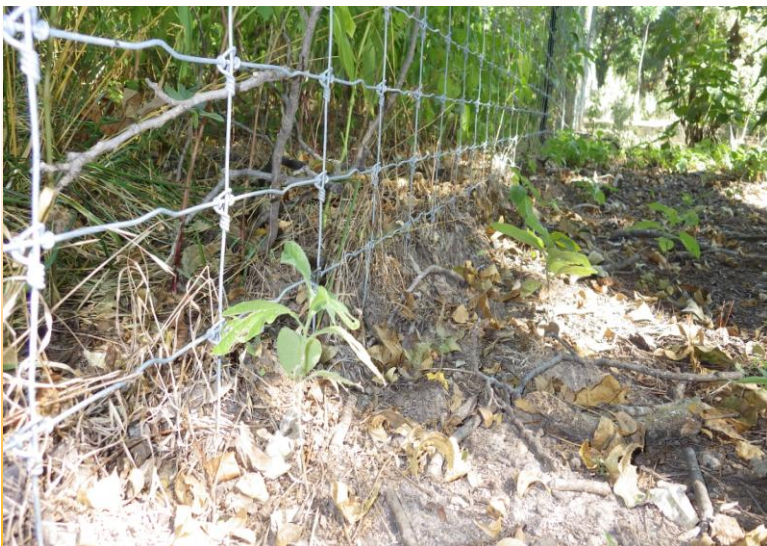
If you look closely at the pecan groves along the river, you will notice that there are only mature trees to be seen. Small trees have little chance to get established before being browsed. This over browsing not only impacts vegetation, it also impacts erosion. Notice the difference between areas inside the exclosure and outside.

In 2010, under the direction of Dr. Tom Arsuffi (above left), the Llano River Field Station constructed an exclosure in the riparian area along the South Llano in Junction.
