# Effects of Flooding on Recreational Access and Navigation on the Llano River and Lake LBJ

## Lyndon B. Johnson Reservoir Survey Results

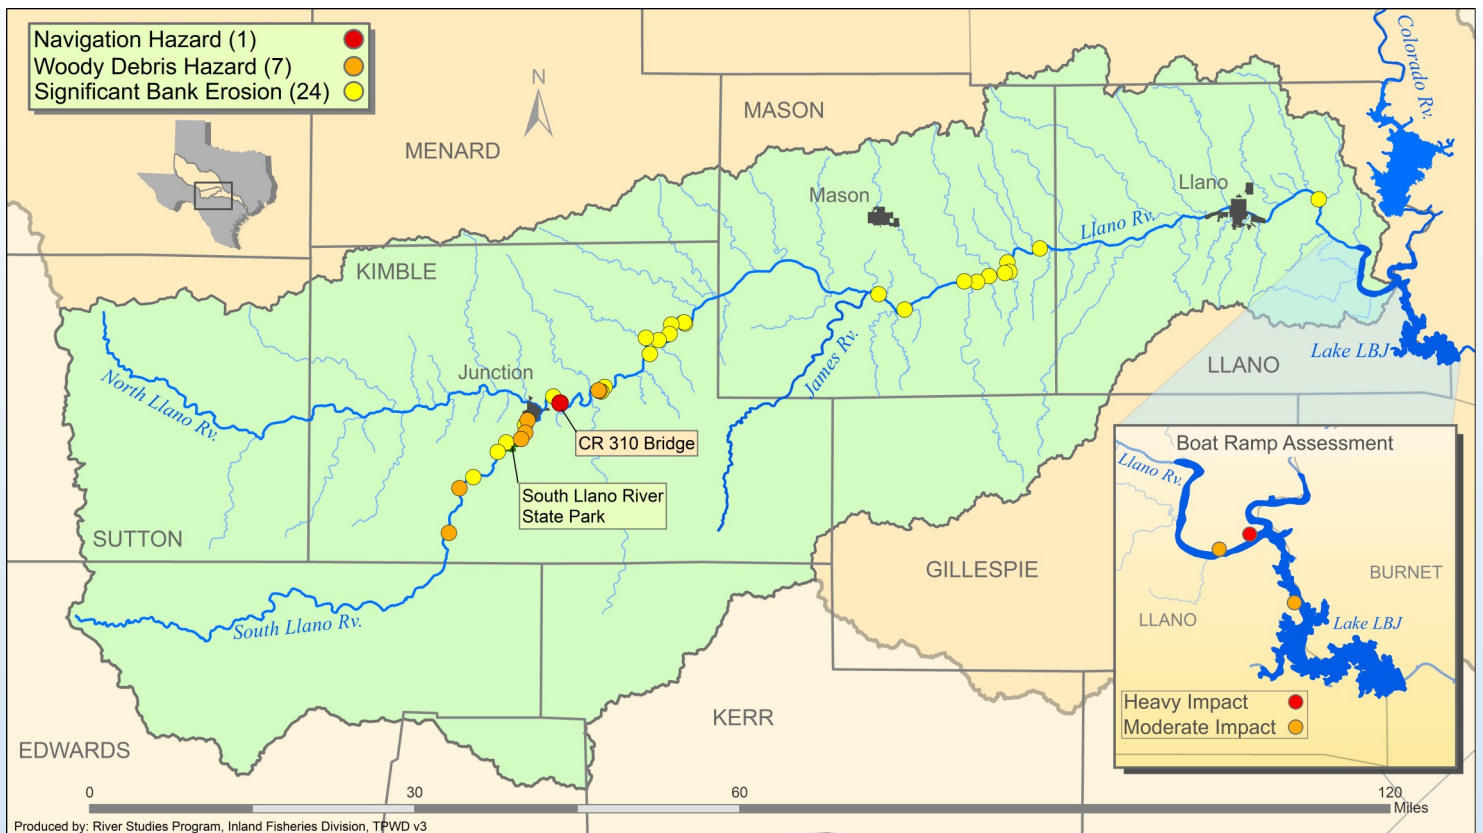
- Of 11 public boat ramps inspected, eight were in good condition, two suffered moderate impacts, and one was heavily affected (see map on opposite page). Substantial impacts were observed at the Kingsland Lions Club including shoreline erosion and loss of courtesy docks and bulkheads, which were being addressed at the time of inspection. Pre-existing submerged damage at the end of the ramp (large holes) may have worsened through erosion. Moderate impacts were observed at Sidney Rowe Memorial Park and Granite Shoals Park including sedimentation and deposition of debris on the ramp and in parking areas.
- Sonar inspections did not reveal underwater hazards at any of the inspected sites.

- Provide resources to parks and public access sites on the reservoir to restore or improve ramp access and parking facilities, rebuild courtesy docks, replace signage, install navigational safety buoys, and stabilize shorelines.
