Floods on the Llano River, Texas — Fall 2018-DRAFT

Llano River Watershed Alliance

Tyson Broad - January 4, 2019

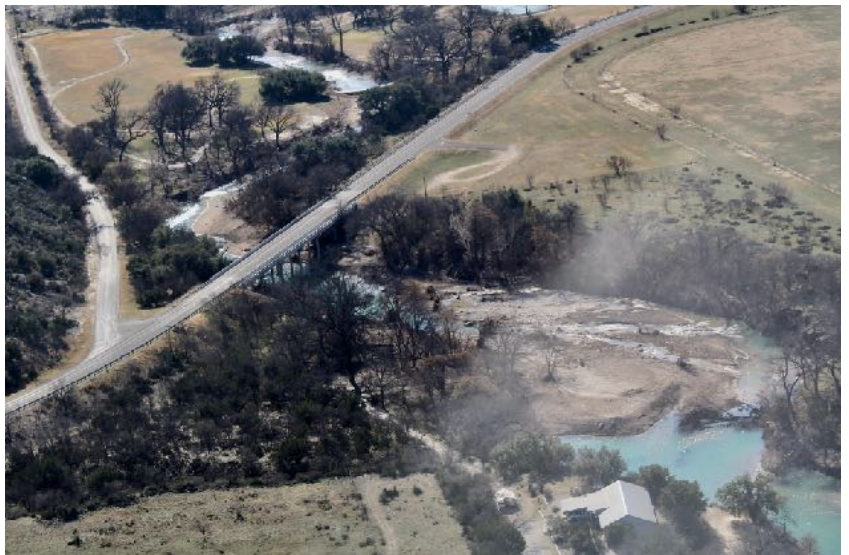
Downstream, the USGS gage on the South Llano River at the Flat Rock Crossing began to rise at 5:15am, was 3 ft higher 15 minutes later, and another 3.5 ft higher in 30 minutes, recording a peak of 26.18 ft at 10am. The South Llano River gage does not record inflows from Cedar Creek downstream, which considering the six to eight-foot gravel bar at its mouth, added significant volumes of water to the flood (Figure 7).

Figure 7. Mouth of Cedar Creek at confluence with South Llano River near Junction. Photo December 14, 2018

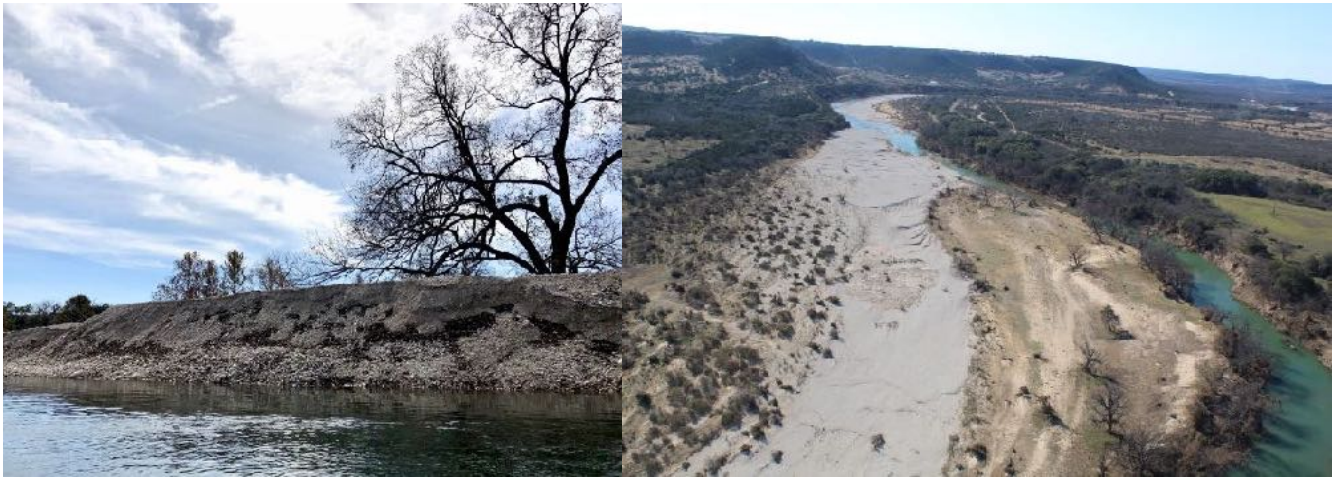
Figure 16. Left: Point Bar Deposit near South Llano River State Park (photo Megan Bean) Right: Floodwater deposits, Llano River below Junction, December 14, 2018

Based upon field observations, it appears that the fall 2018 Floods carried considerable energy. Large deposits of gravel were deposited on point bars, in some instances raising the height of the point bars by several feet (Figure 16). Many of the mid-channel point bars, or islands, were reworked or eliminated completely. In other instances, gravel was deposited out of the channel and into the floodplain. Despite the volume of energy in the floods, with one minor exception, it does not appear that avulsion (abandonment of an existing channel and formation of a new river channel) occurred across any of the meanders. In fact, it appears that the meanders along the South Llano River grew slightly larger due to the flooding.

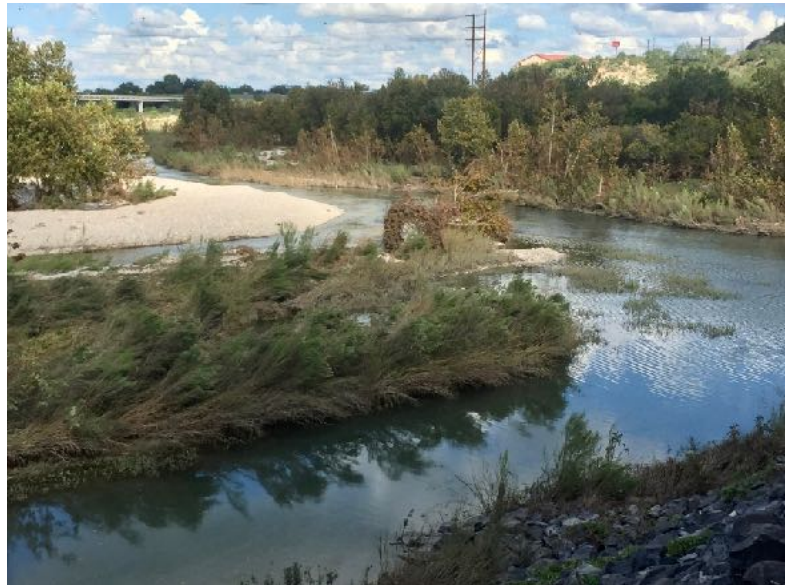
Figure 20. Confluence of North and South Llano River. Note new mouth of North Llano in background.

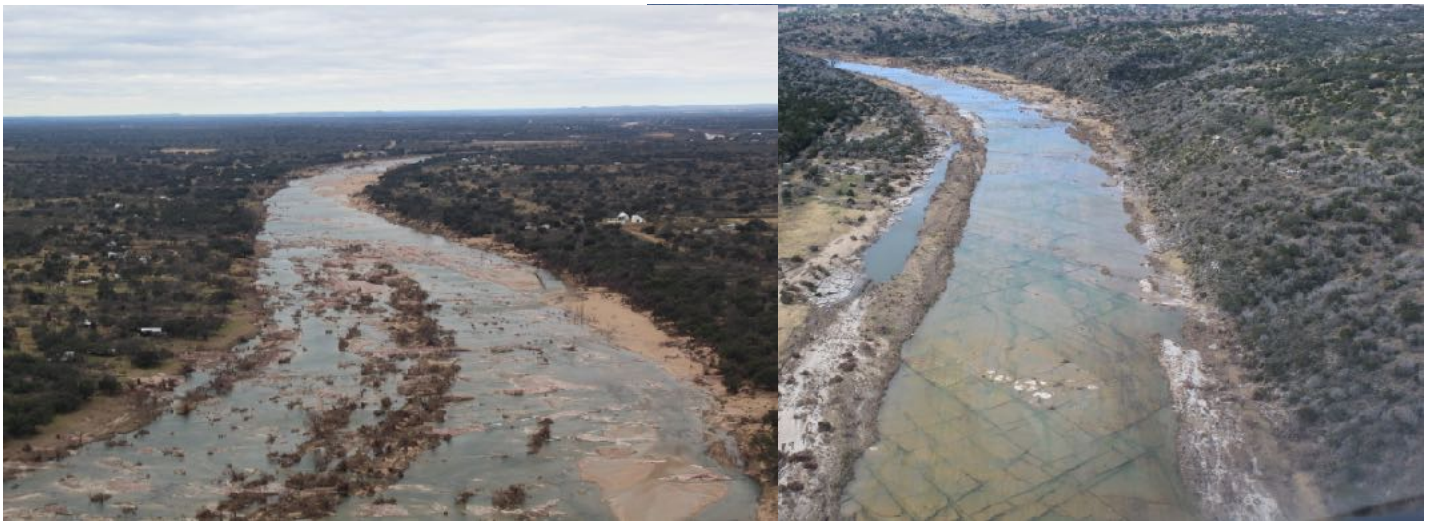
Figure 21. Left: Llano River between Castell and Llano near Schneider Slab. Right: Llano River below Yates Crossing.

along this stretch of the Llano River appear to have been less impacted than further upstream and channel scouring less common (Figure 21).

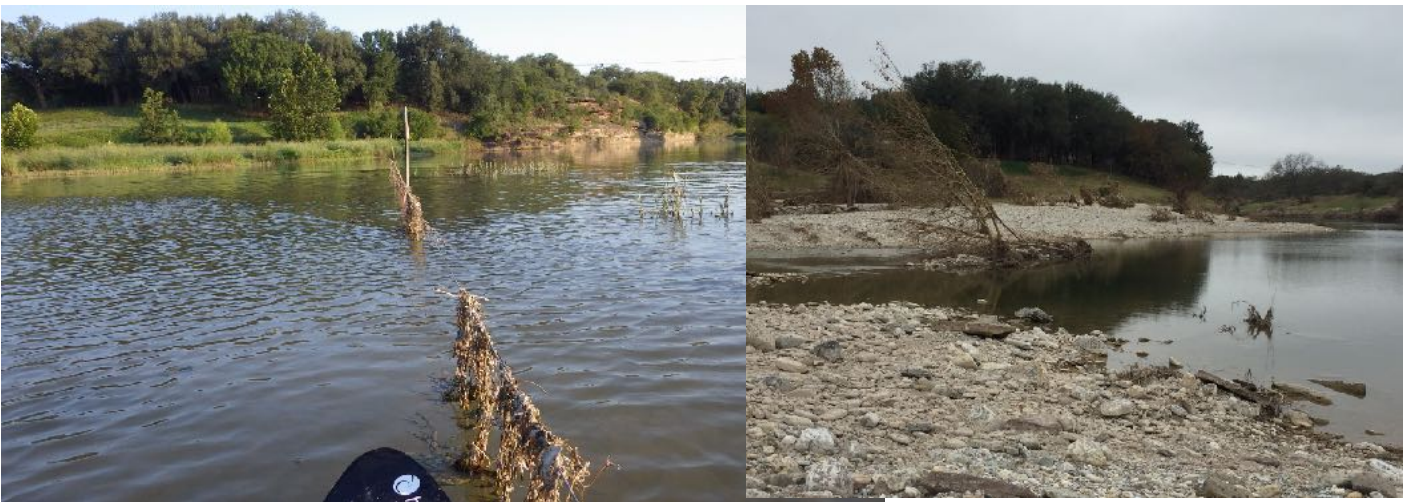
The James River Crossing (RR 2389) is a popular access point located on an island of the Llano River just downstream of the James River confluence. As the island is considered public land, due to its location in a navigable waterway, use of the island is governed by the Mason County - James River Crossing Local River Access Plan. This plan was developed by the Mason County Commissioners in 2004 following passage of Senate Bill 155, which limited the use of motorized vehicles in state-owned waterways. As noted above, the island was inundated with gravel from the outflows of the James River, and the channels on both sides of the island were reworked and widened by the flood flows (Figure 27). Downed trees at the entrance to the north channel could cause a navigation hazard for paddlers. Riparian vegetation was destroyed or heavily damaged. The crossing has reopened but was slightly damaged with the loss of concrete slabs on the downstream side. Access to the island was impacted at first, due to the deposition of sand and gravel, but it becoming easier as the gravel is compacted by travel on re-emerging access roads.

Figure 27. Mouth of the James River, August 2017 and October 2018

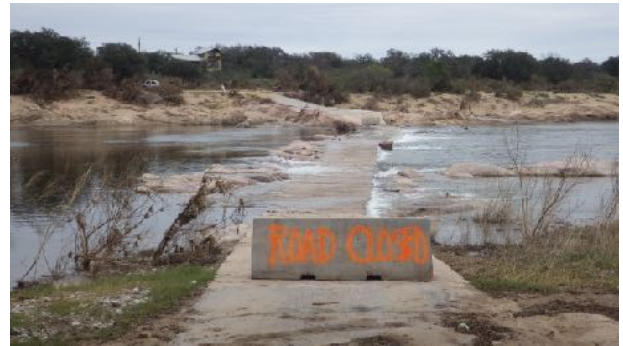
There are three low-water crossings in Llano County: Castell, Schneider Slab Crossing, and Scott's Slab (or Crossing) in order downstream. Scott's Slab was closed due to high water until mid-November, but has now reopened. Schneider Slab remains closed. Access does not seem to have been altered. The Castell Bridge has reopened, with no significant changes to recreational access. The proposed RACA sites at the Castell Bridge and downstream towards Schneider Slab (Figure 28) lost some vegetation during the flood and may benefit from some vegetative restoration, one of the components of the RACA program.

Figure 28. Schneider Slab, Llano River, November 10, 2018

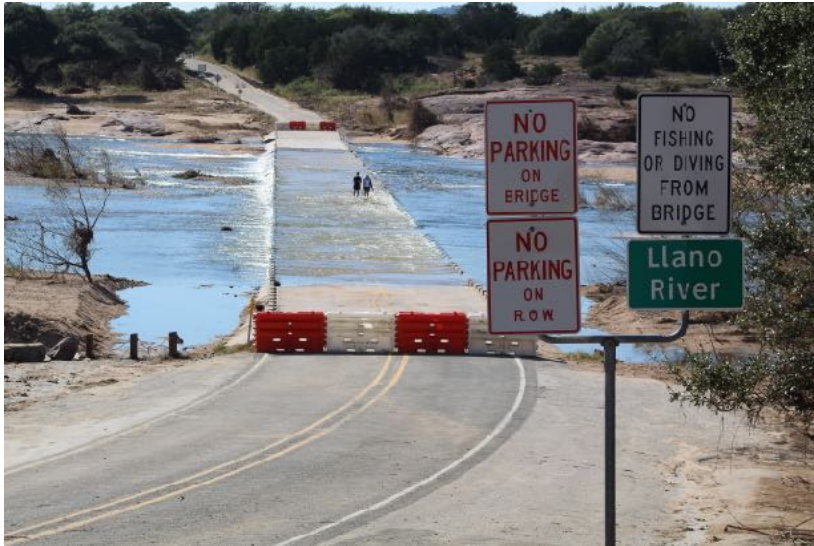
The Kingsland Slab is located just upstream of the point where the Llano River flows into LBJ Reservoir. The Slab was not damaged, but the parking areas at the Slab will require maintenance. The Slab was closed due to high water until November 13th (Figure 30).

Figure 30. Barricades at Kingsland Slab, November 4, 2018
